Magazine for the Structural Engineers Association of New York

2018 VOLUME 23 NO. 4

WOOD CONDITION ASSESSMENT

By Ron Anthony, Anthony & Associates, Inc.

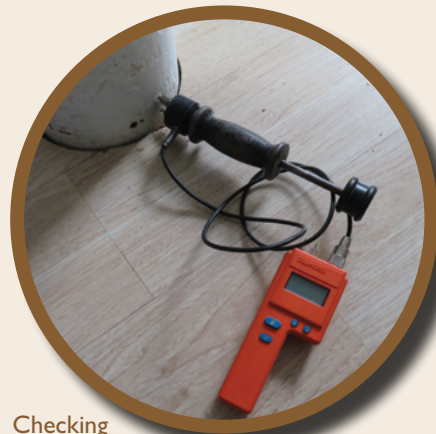
Checking the moisture content of a timber column using a resistance-type meter

Moisture contents from 20 to 30 percent indicate areas of concern where sufficient moisture is present for fungi to grow but not sufficient to indicate advanced decay. Moisture contents above 30 percent are often an indication of advanced decay with internal voids and / or surface deterioration.

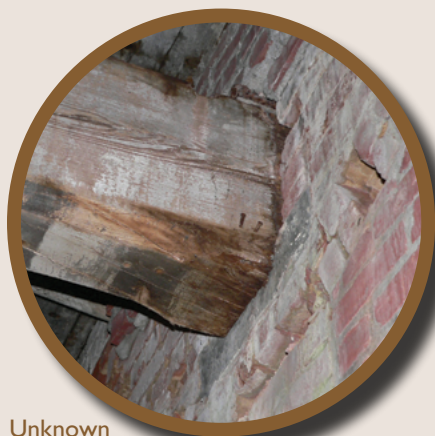
Unknown beam condition and bearing area within masonry wall

Inaccessible locations have presented problems during assessment of existing buildings. The most common areas are beam pockets where timbers bear on masonry walls and where roof rafters or trusses bear on a top plate. Connections are also difficult to assess in-situ, either beam-column

connections or timbers connected to other materials. Unfortunately, these are areas where moisture penetrates porous bricks or mortar joints and where roof leaks or ice dams provide means of water ingress. Deterioration is often the result. Yet we have no reliable means to locate and quantify this deterioration. While probing, resistance drilling, digital radioscopy and stress wave measurements can shed light on whether problems are present, they fail to give us the complete information we desire to determine whether the wood is sound and if adequate bearing exists. In those cases, probes may be necessary to gain a better understanding of conditions.

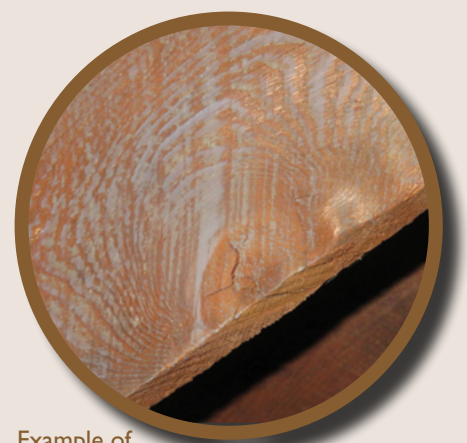
Example of an edge knot on a rafter

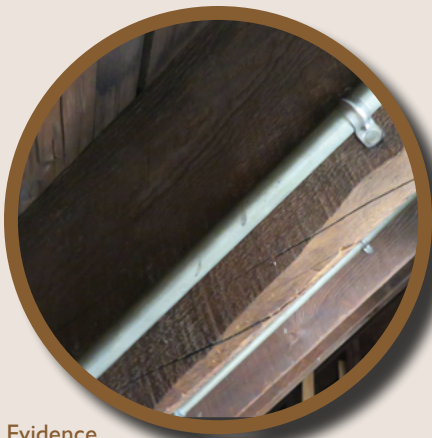
Evidence
of slope of grain on a rafter as
indicated by the seasoning checks

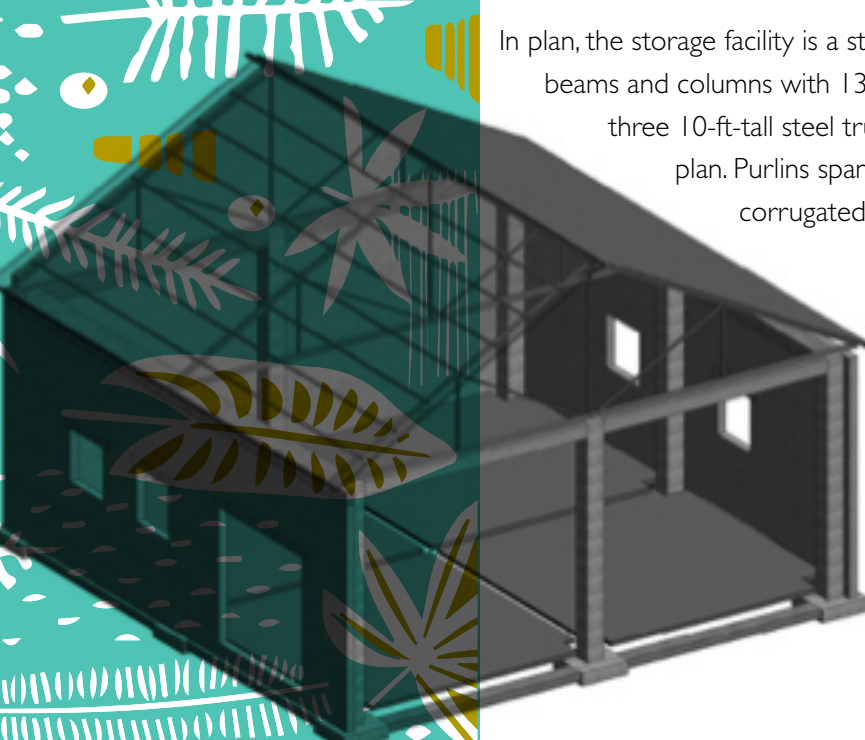
In plan, the storage facility is a straightforward 40-ft x 40-ft square, framed by concrete beams and columns with 13-ft-high CMU side walls. A gabled roof supported by three 10-ft-tall steel trusses, consisting of HSS square tubes, span the 40-ft plan. Purlins span between the trusses to allow for the attachment of corrugated roof sheeting.
